7. The Off the Mouth of the Mabuchi River Earthquake, 1931

(March 9th, 12:49. 40°36'N, 141°54'E,
r=529 km, M=7.5)

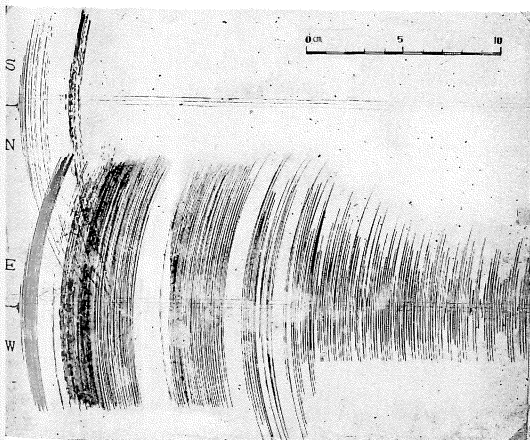
1. Hakodate (P)

No of Fig.	Station	Int.	Ins.	Comp.	V	T	r	v	ps	No m. f.
1	Hakodate	IV	P(O)	{ N E	10	4.5 6.1	0.05 0.08	—	24.5	259
2	"		P(C)	H	30	4	—	—	20.5	264
