# **Installation and Operation of Ultrasonic Anemometers in JMA**

<sup>1</sup> Japan Meteorological Agency (JMA; RIC Tsukuba, RA-II)

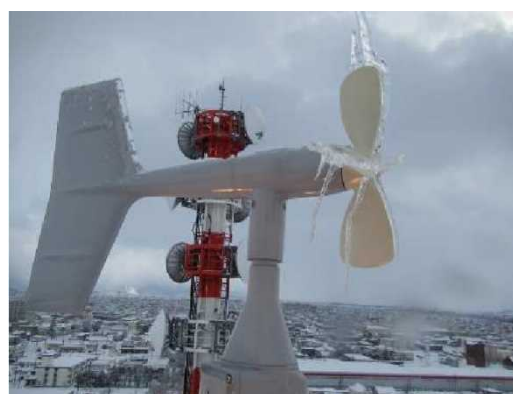
**Figure 2: Frozen windmill-type anemometer**

The moving parts in windmill-type anemometers (such as propellers and unit parts) need to be periodically replaced and reinspected. In winter, snow and ice can impair wind speed/direction analysis (Fig. 2).

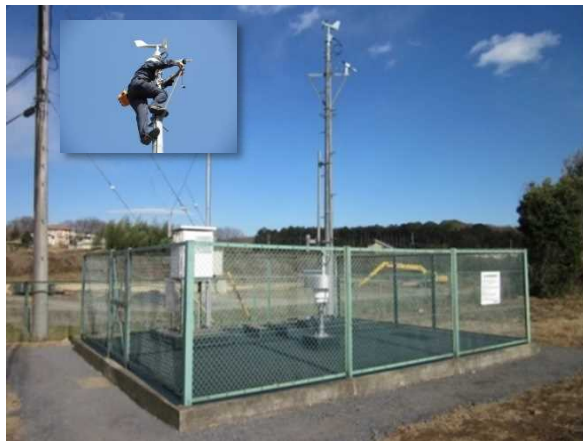
**Figure 3: AWS and inspection at high altitude**

Conversely, ultrasonic anemometers have no moving parts, thereby facilitating maintenance and the cost of work at high elevations (Fig. 3). With these benefits, ultrasonic anemometers were considered in conjunction with instrument updates.

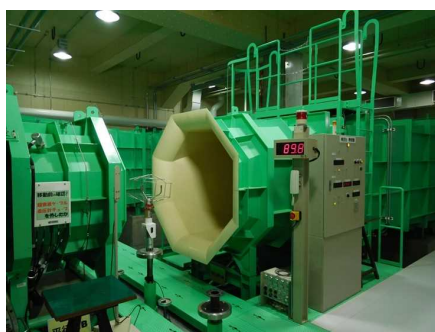
**Figure 6: Wind-tunnel analysis (Model A)**

Wind tunnel facilities at JMA's Meteorological Instrument Center were used to verify that accurate basic wind direction/speed performance met the specified accuracy with bird repellence. Accuracy is within 0.3 m/s at 6 m/s or less, and 5% or less otherwise. As these units have three or four ultrasonic sensors, checking was also performed to verify whether wind speed was affected by direction and any effects from bird shields (Fig. 6).

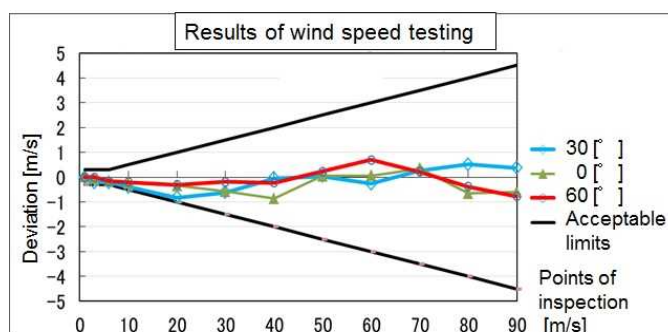
**Figure 7: Test results for wind speeds of 1 – 90 m/s (Model B)**

Instrumental deviation was checked with bird shields to verify orientation standards at 0 (north), 30 and 60 degrees with wind-tunnel speeds ranging from 1 to 90 m/s (Fig. 7).

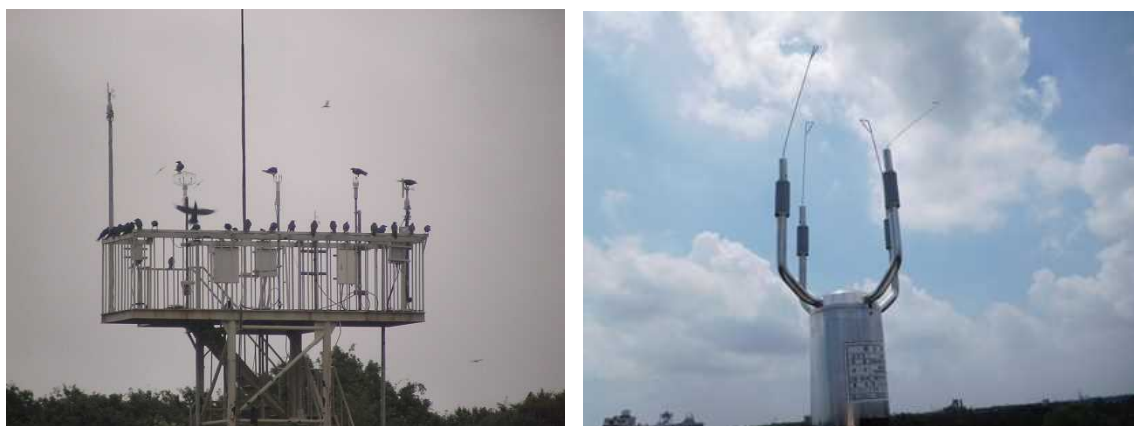
**Figure 12: Left: Crows on anemometers; right: bent bird protection wires**

Crows often sat for long periods on anemometers. Few ultrasonic sensors were damaged, but in one case a Model C wire was bent, indicating potential issues with the shape and strength of avian protection measures (Fig. 12).

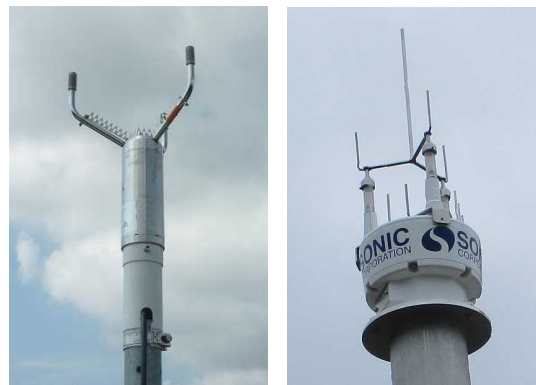
**Figure 13: Ultrasonic anemometers**

Based on the test results, the manufacturer modified the ultrasonic anemometer bird protection and software (Fig. 13), providing observation with accuracy and frequency similar to those of the windmill type. The ultrasonic type has many advantages over the windmill type in terms of maintenance and cost. Accordingly, these units have been gradually introduced since 2021, with planning for installation at all 687 AWS locations.

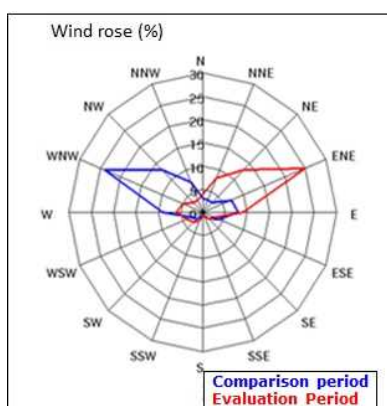
**Figure 15: Single station wind direction (compared to the previous two years for August 2012)**

HQC is more of a comprehensive judgment based on meteorological expertise. In conjunction with AQC, it supports quality control with tools such as diagrams and graphs (see Figs. 15 and 16 for wind direction frequency data with a windmill-type anemometer at a certain AWS). Figure 15 shows wind direction opposite to that of the east-west direction compared to the past two years due to an error in system settings, while Fig. 16 shows an overall absence of east-direction data since August 2021 (red) due to instrument failure.
